# Abandoned Uranium Mine Site Assessment for the Section 9 Site (NM0079)

**FINAL REPORT**

NM0079

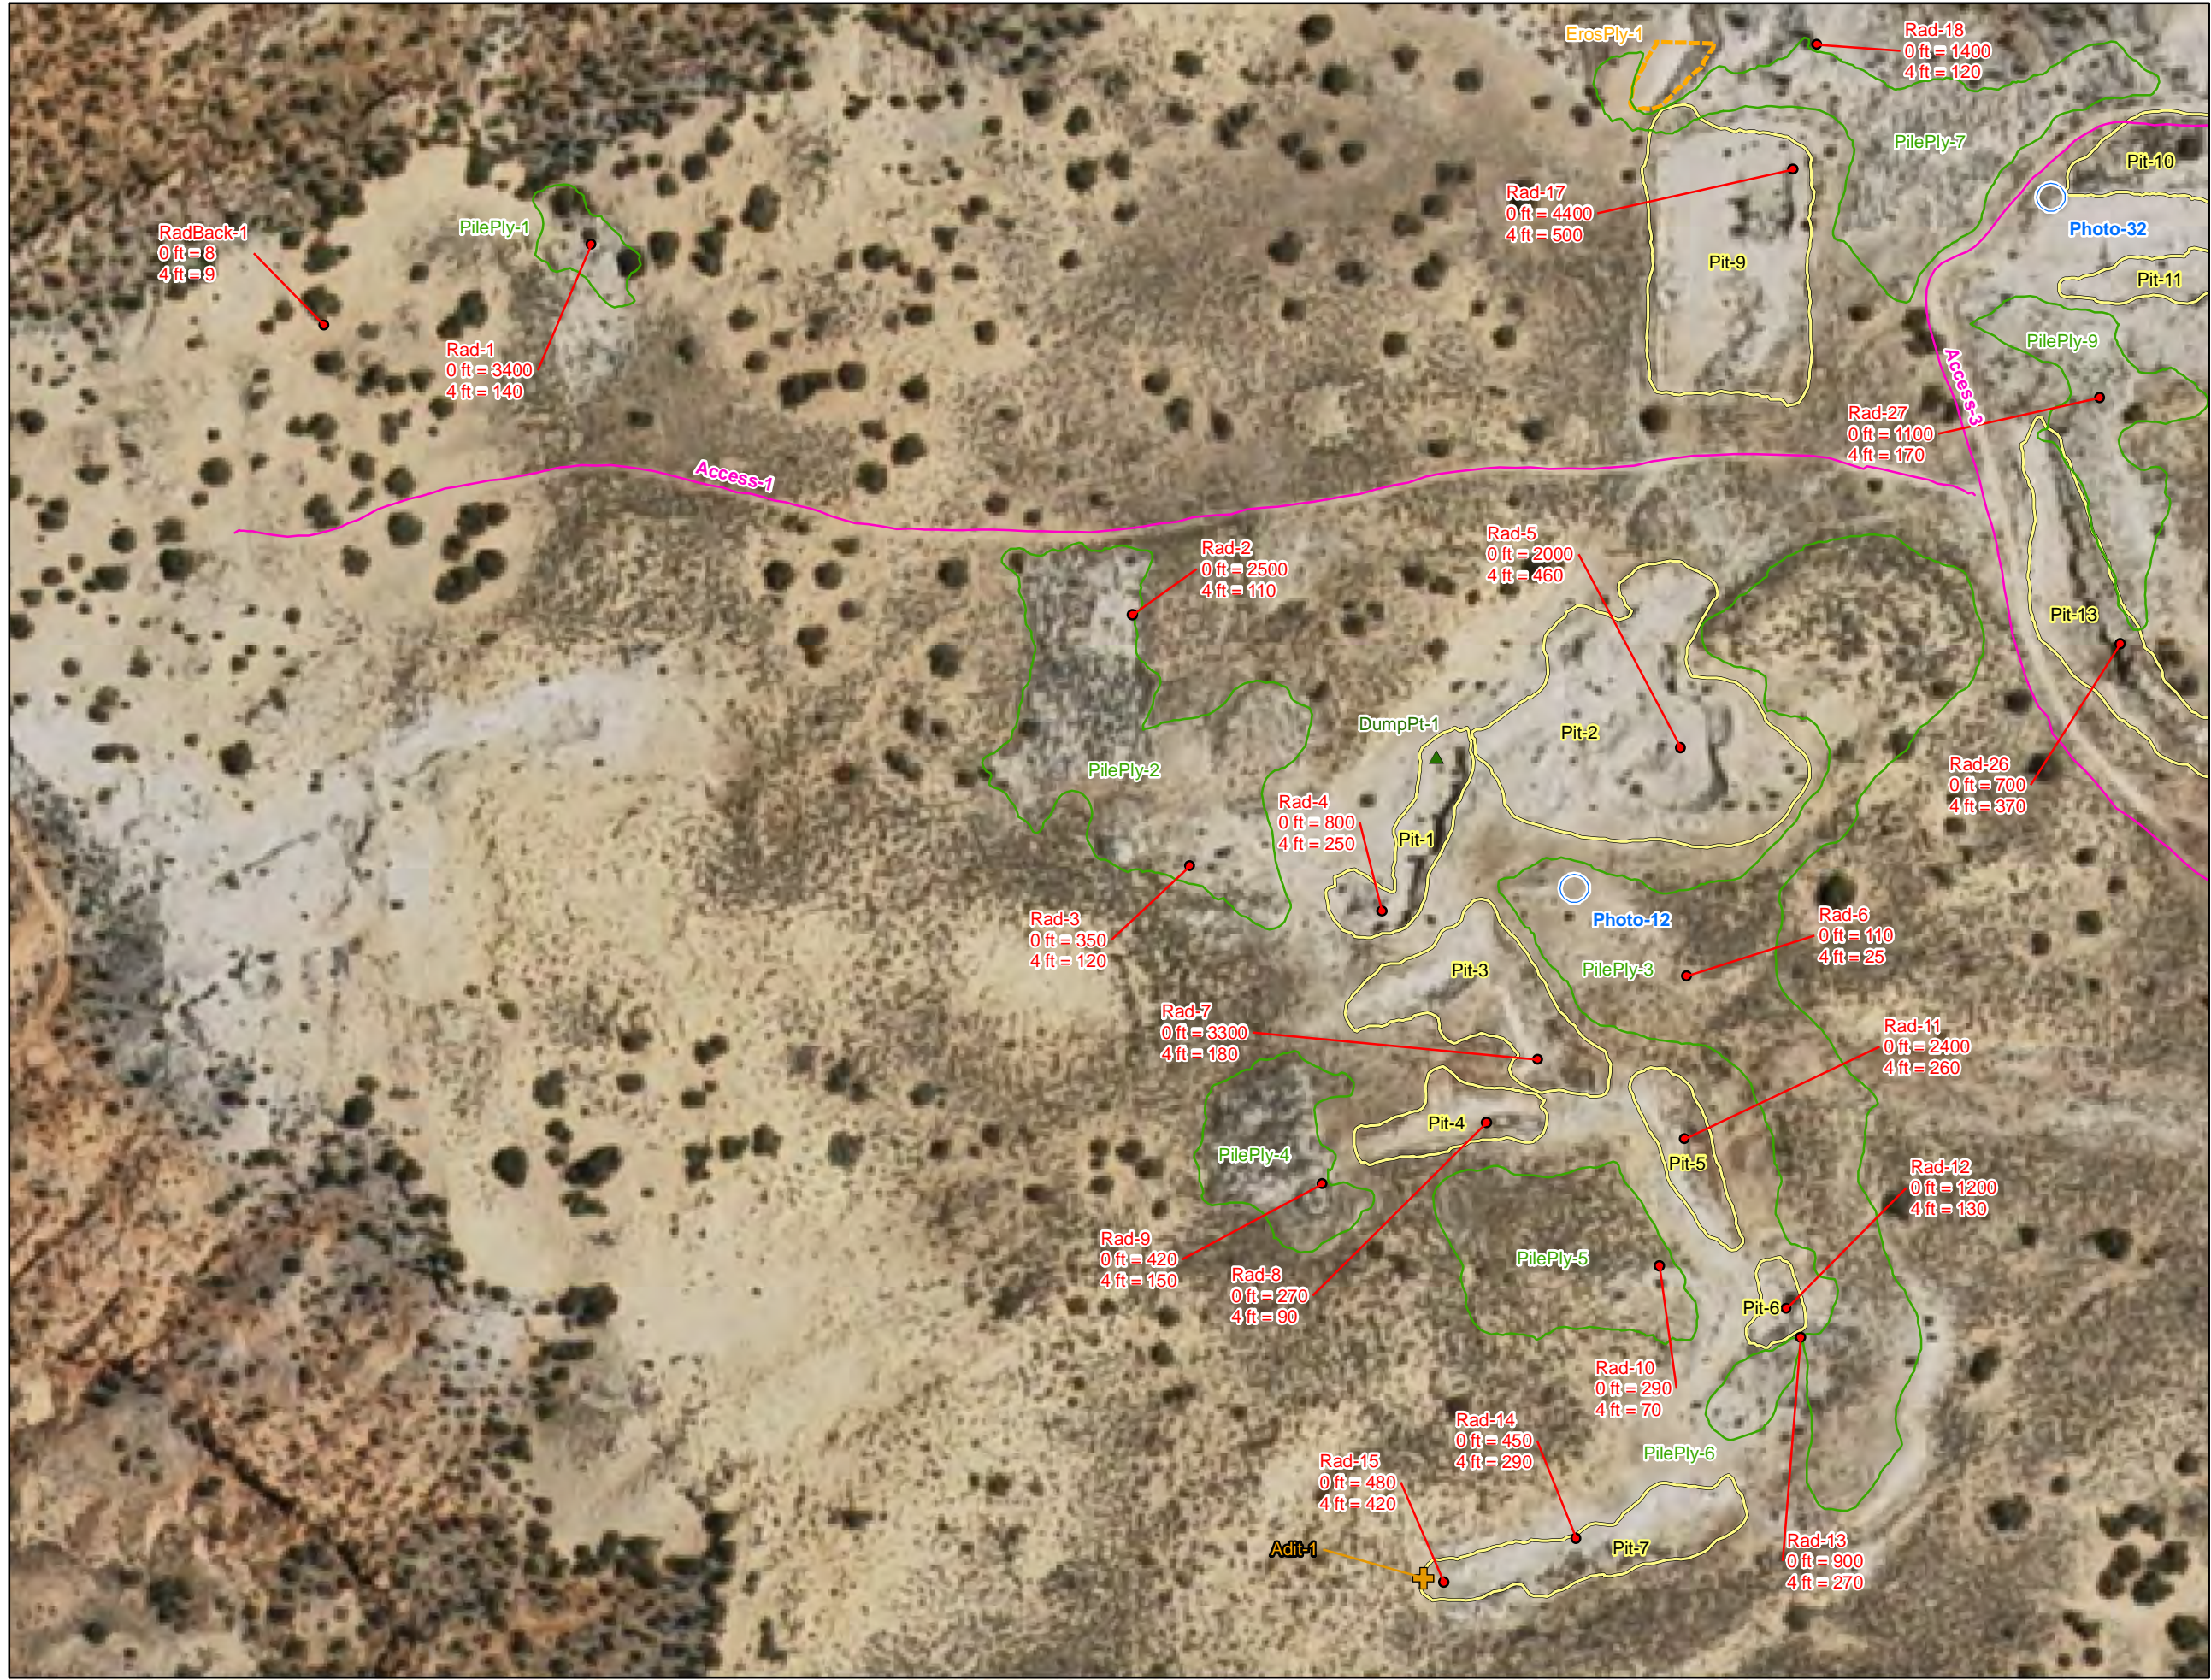
**Figure 4a**  
**Site Map on**  
**Aerial Photo**  
**NM0079-Section 9**  
**Northwestern Area**  
 Abandoned Uranium  
 Mine Assessment

Twenty open pits were found at the AUM Site. Eight of these pits (Pit-1, Pit-2, Pit-3, Pit-4, Pit-5, Pit-6, Pit-7, and Pit-9) are located in the Northwestern Area of the Site (see Figures 4a and 4b). These pits tend to be linear (see Photo 13 in Appendix A), with the exception of Pit-9 (see Photo 27 in Appendix A). These pits form a rough north-south trend, with Pit-9 in the north and Pit-7 in the south. The highest gamma radiation measurement was at radiation survey point Rad-17 in Pit-9, with 4400  $\mu\text{R/hr}$  at 0 ft above ground. Of the remaining seven pits, four had gamma radiation readings over 1000  $\mu\text{R/hr}$  at 0 ft above ground. Adit-1 is located at the western end of Pit-7.

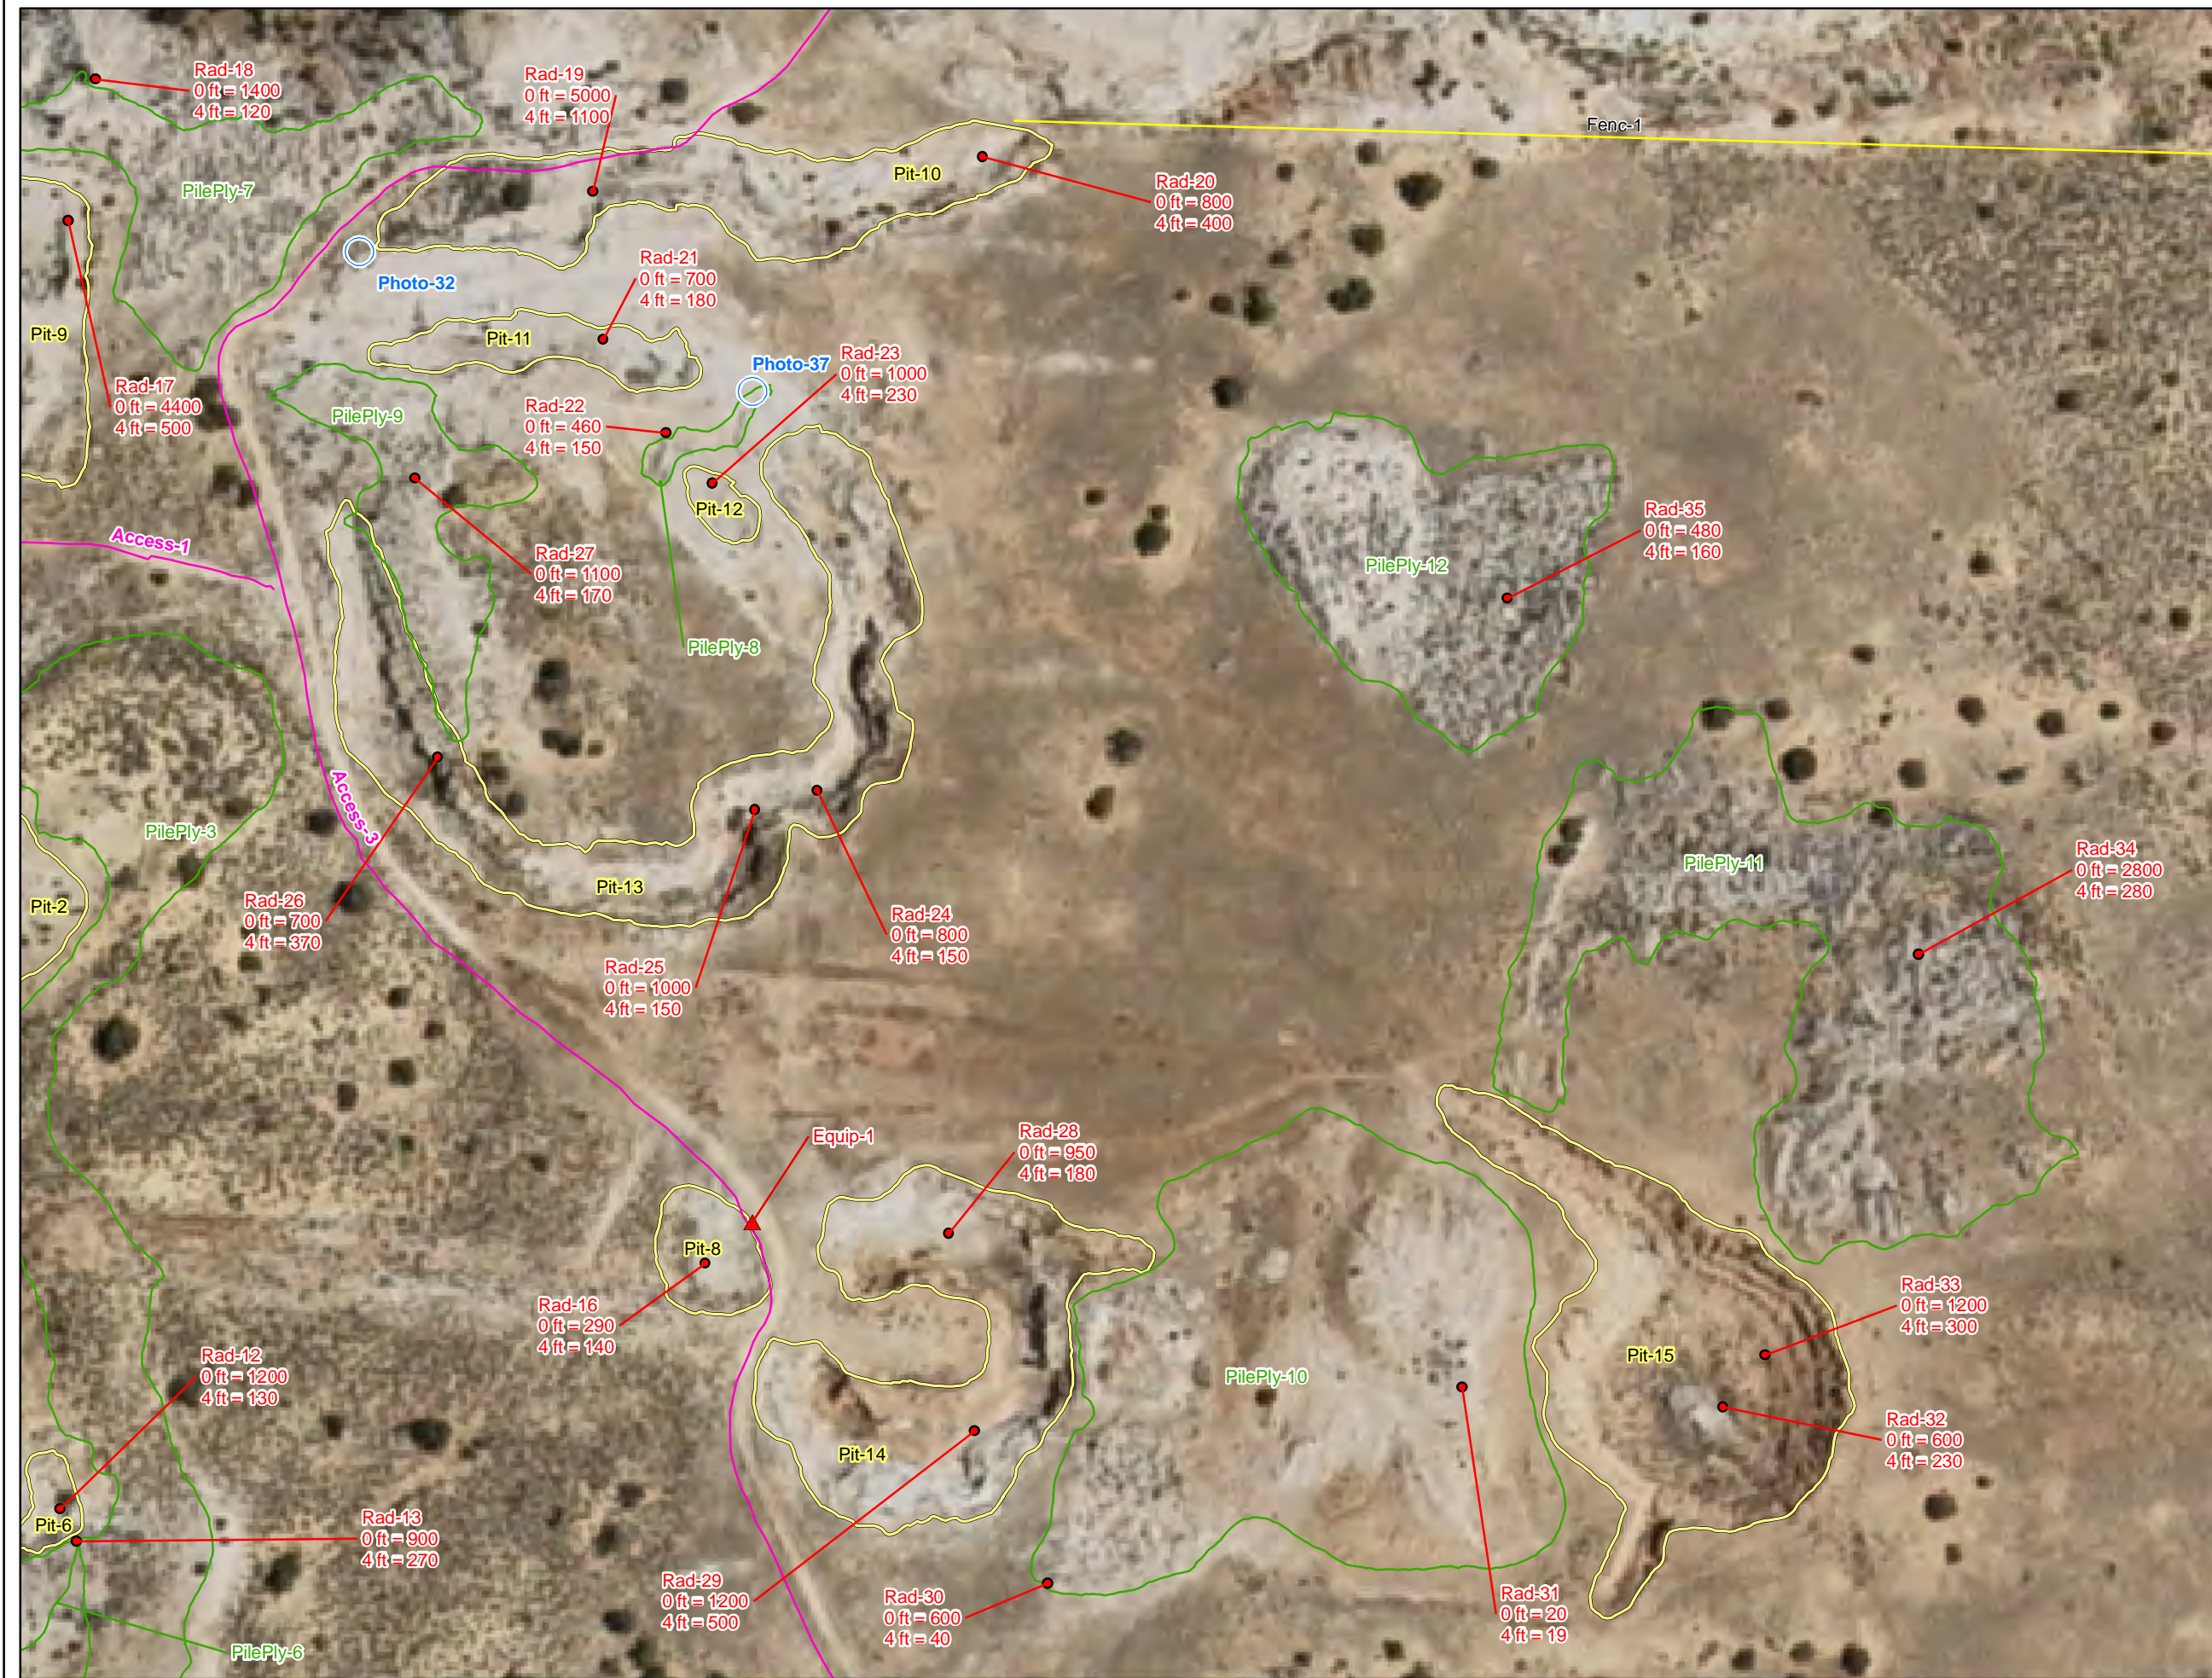
**Figure 5a**  
**Site Map on**  
**Aerial Photo**  
**NM0079-Section 9**  
**Northeastern Area**  
 Abandoned Uranium  
 Mine Assessment

The Northeastern Area of the AUM Site contains seven pits (Pit-8, Pit-10, Pit-11, Pit-12, Pit-13, Pit-14, and Pit-15). Two of these pits (Pit-10 and Pit-11) are linear, oriented generally east-west (see Photo 34 in Appendix A). Two of the pits are C-shaped, one opening to the north (Pit-13; see Photo 43 in Appendix A) and one opening to the west (Pit-14; see Photo 51 in Appendix A). The final three pits (Pit-8, Pit-12, and Pit-15) are circular. Pit-15 is referred to as the “Eyeball Pit” in the Anderson Report. See Photos 54 and 55 in Appendix A for views of Pit-15. The maximum gamma radiation measurement was over 5000  $\mu\text{R/hr}$  (off the scale of the scintillometer used in this survey) at radiation survey point Rad-19 in Pit-10.

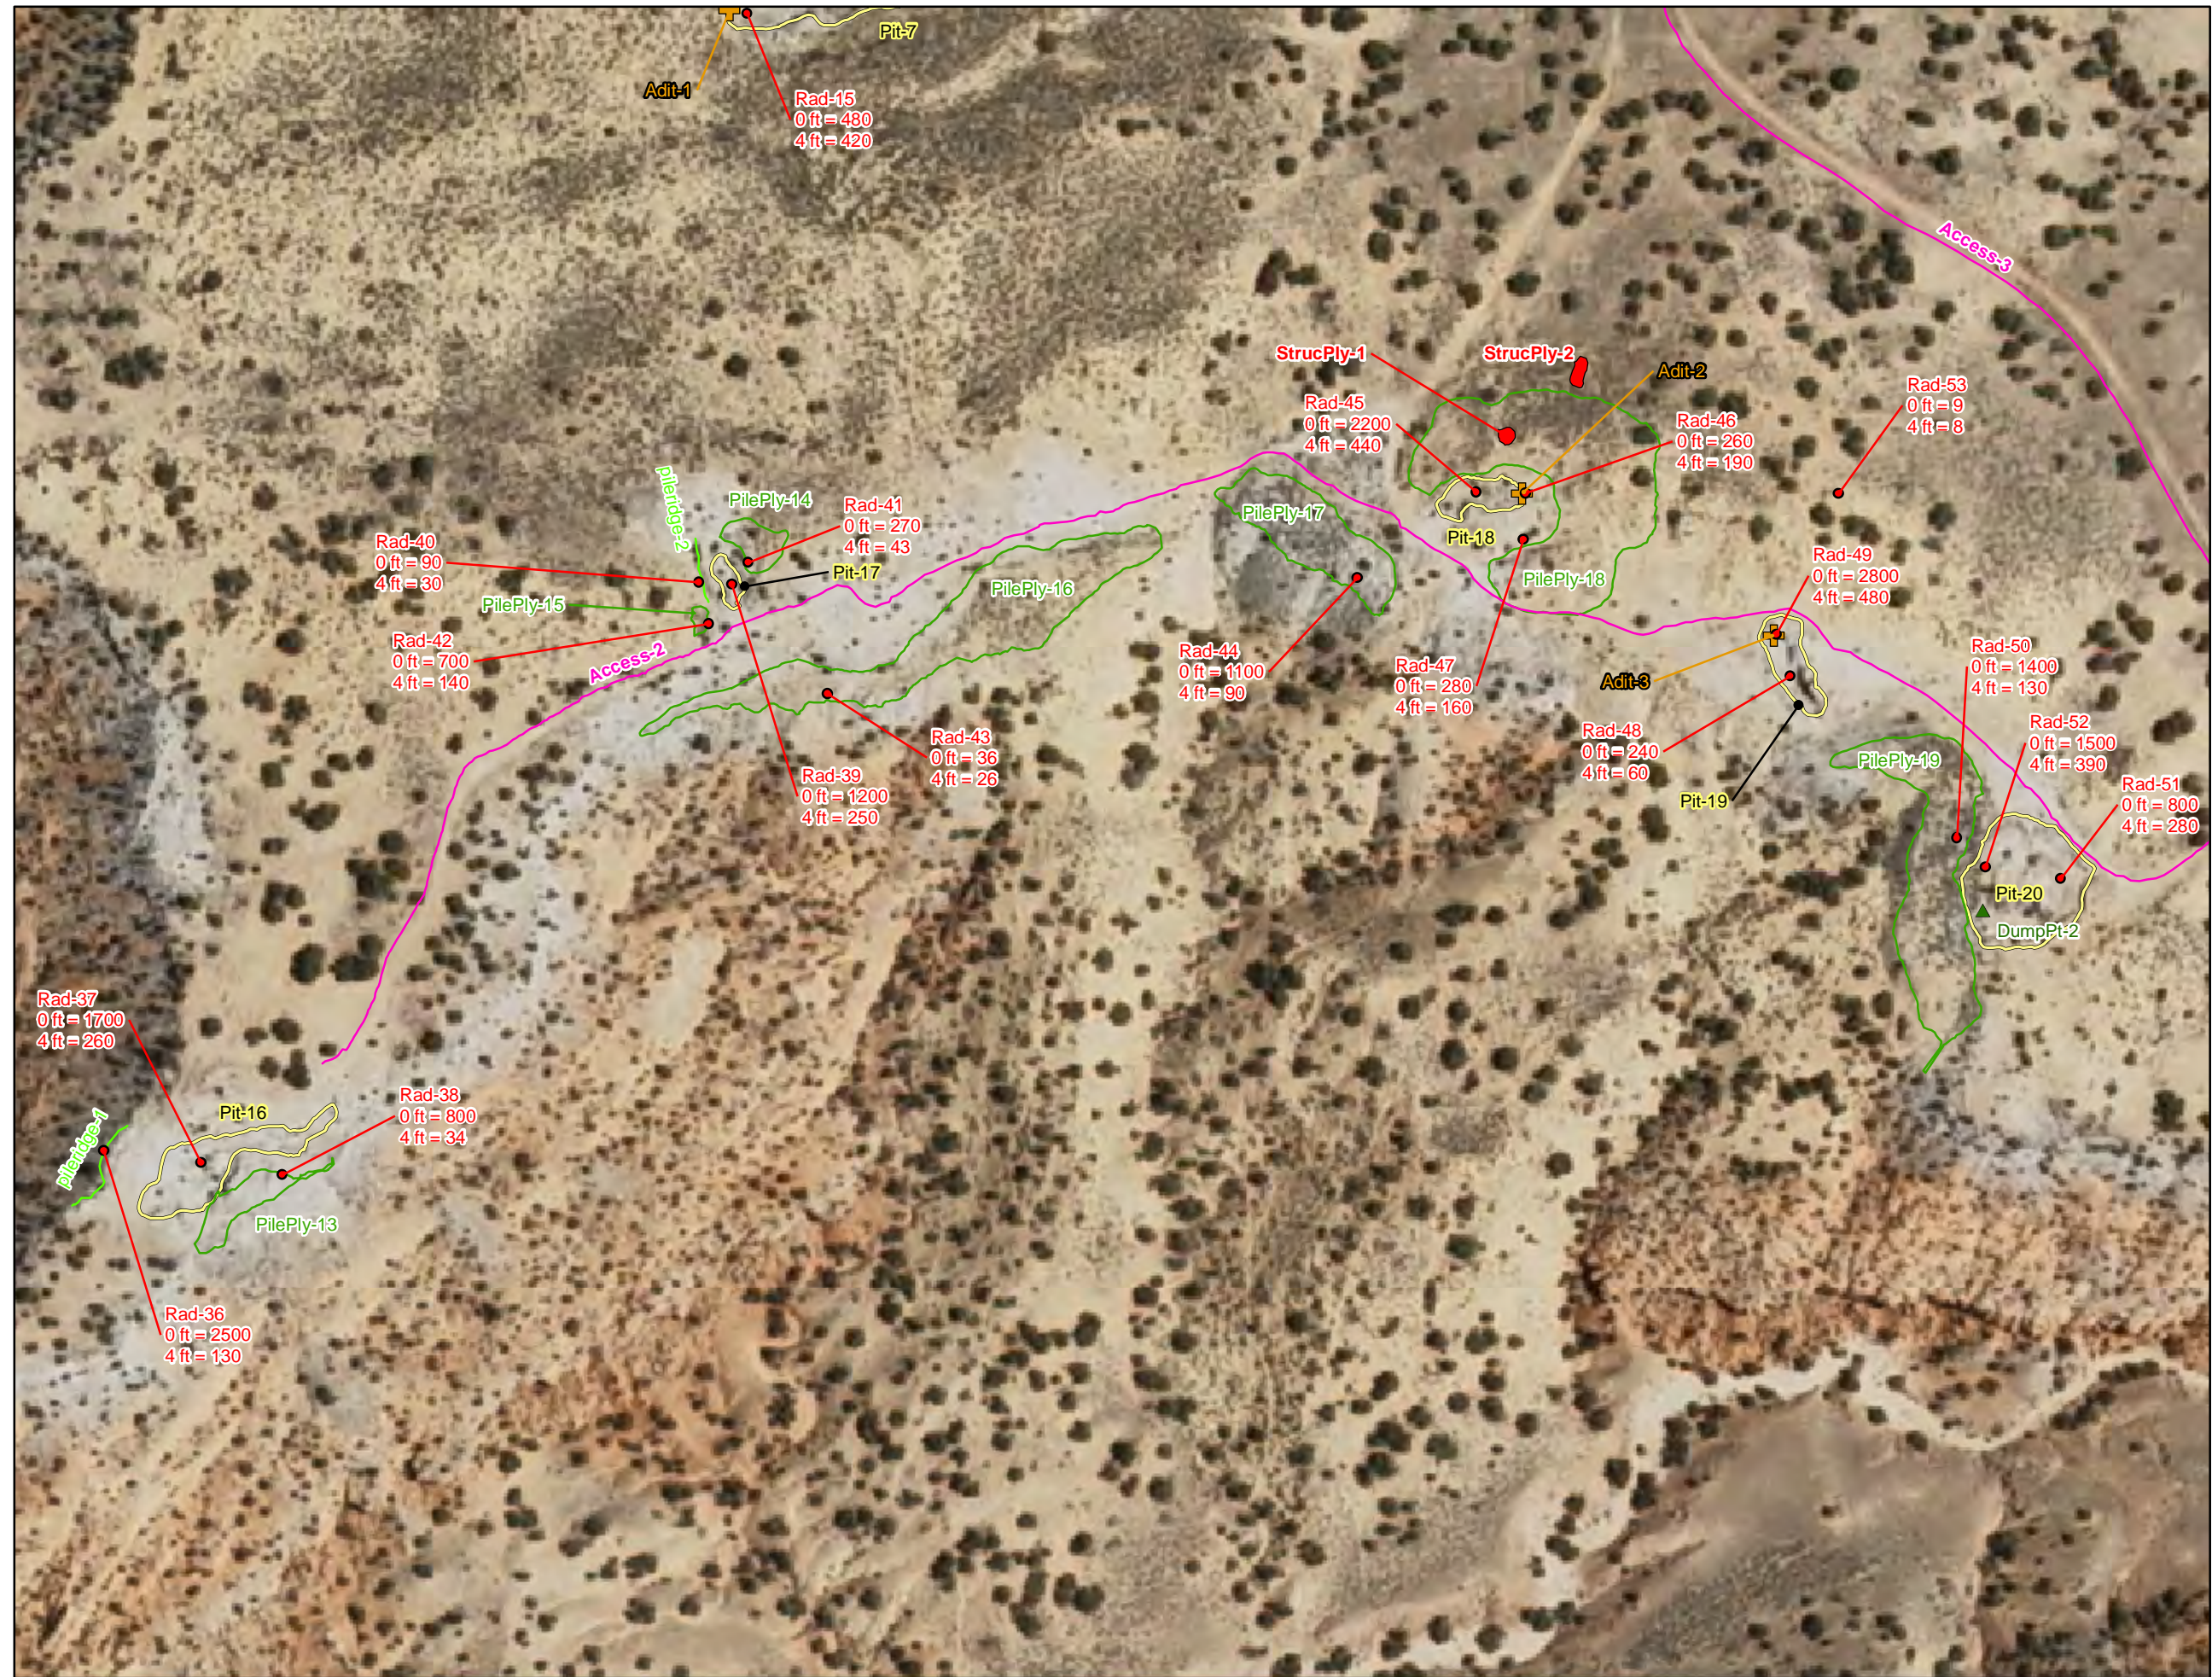
**Figure 6a**  
**Site Map on**  
**Aerial Photo**  
**NM0079-Section 9**  
**Southern Area**  
Abandoned Uranium  
Mine Assessment

The Southern Area of the AUM Site contains five pits (Pit-16, Pit-17, Pit-18, Pit-19, and Pit-20). These pits are located along the edge of the mesa and tend to be smaller than pits elsewhere on the Site (see Photo 64 in Appendix A). Two pits (Pit-18 and Pit-19) contained adits. The maximum gamma radiation measurement was 2800  $\mu\text{R/hr}$  at radiation survey point Rad-49 at Adit-3 in Pit-19.

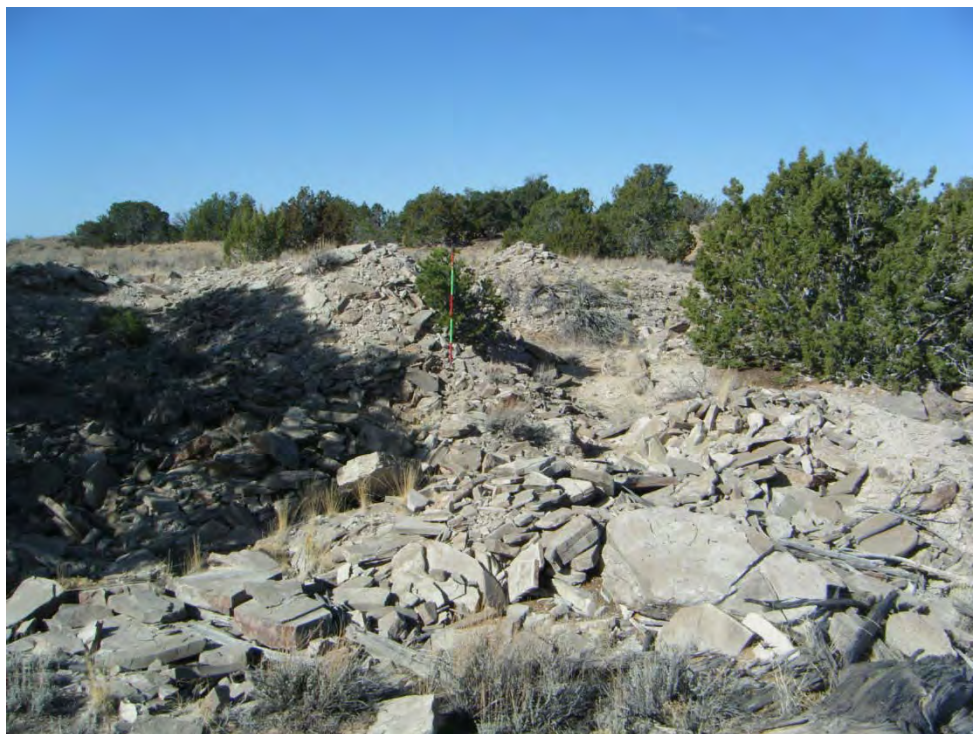
Appendix A). The maximum gamma radiation measured on pile at the AUM Site was 3400  $\mu\text{R/hr}$  at 0 ft above ground at radiation survey point Rad-1 on PilePly-1.

Photo 1-Looking west at PilePly-1.

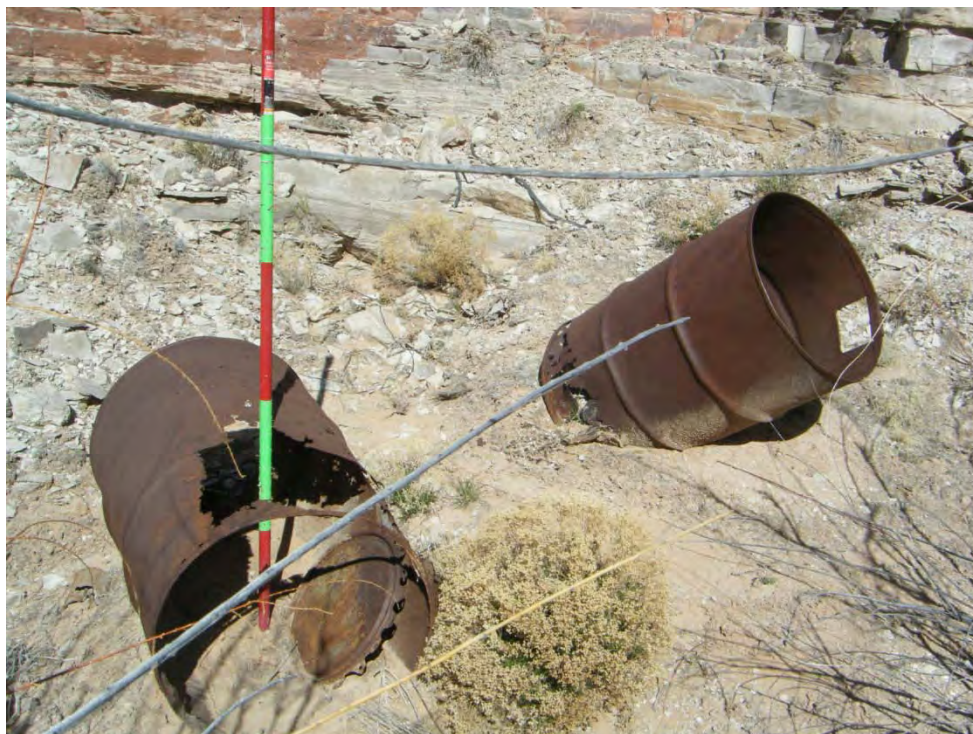
Two trash dumps were found in pits onsite. DumpPt-1 consists of several 55 gallon drums (see Photo 7 in Appendix A). This dump is located in the Northwestern Area of the Site. DumpPt-2 consists of tires, metal, and glass (see Photo 84 in Appendix A). It is located in the Southern Area of the Site. One piece of mining equipment (Equip-1) was also found in the Northeastern Area of the Site (see Photo 26 in Appendix A). The piece of equipment is a water truck that is currently in use in a permitted exploration project. It is not related to legacy mining at the Site.

Photo 7-Looking west at DumpPt-1.

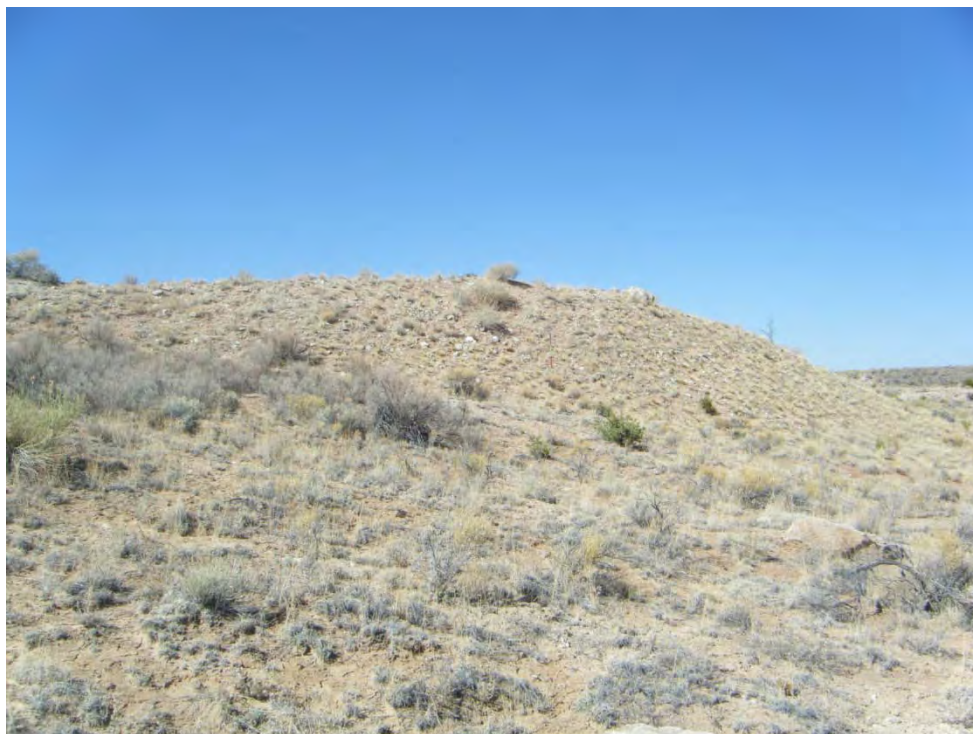
Overburden piles can be very large at the AUM Site. One overburden pile (PilePly-3) is over 1000 ft long and consists mostly of aeolian sand with a few scattered rocks (see Photo 11 in Appendix A).

Photo 11-Looking southwest at PilePly-3.

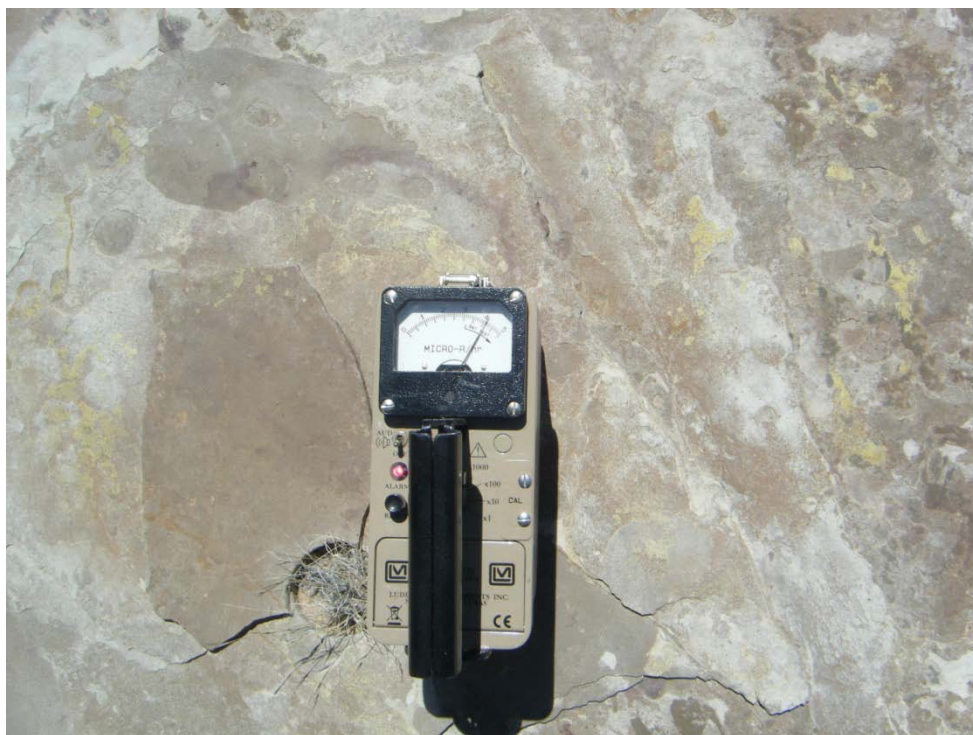
The maximum gamma radiation reading for the AUM Site was over 5000  $\mu\text{R/hr}$  at 0 ft above ground at radiation survey point Rad-19 in Pit-10 (see Photo 33 in Appendix A). Other notable radiation readings were taken at radiation survey point Rad-1 (3400  $\mu\text{R/hr}$  at 0 ft above ground) on PilePly-1 and radiation survey point Rad-17 (4400  $\mu\text{R/hr}$  at 0 ft above ground; see Photo 28 in Appendix A) in Pit-9.

Photo 28-Radiation survey point Rad-17 (4400  $\mu\text{R/hr}$  at 0 ft above ground).

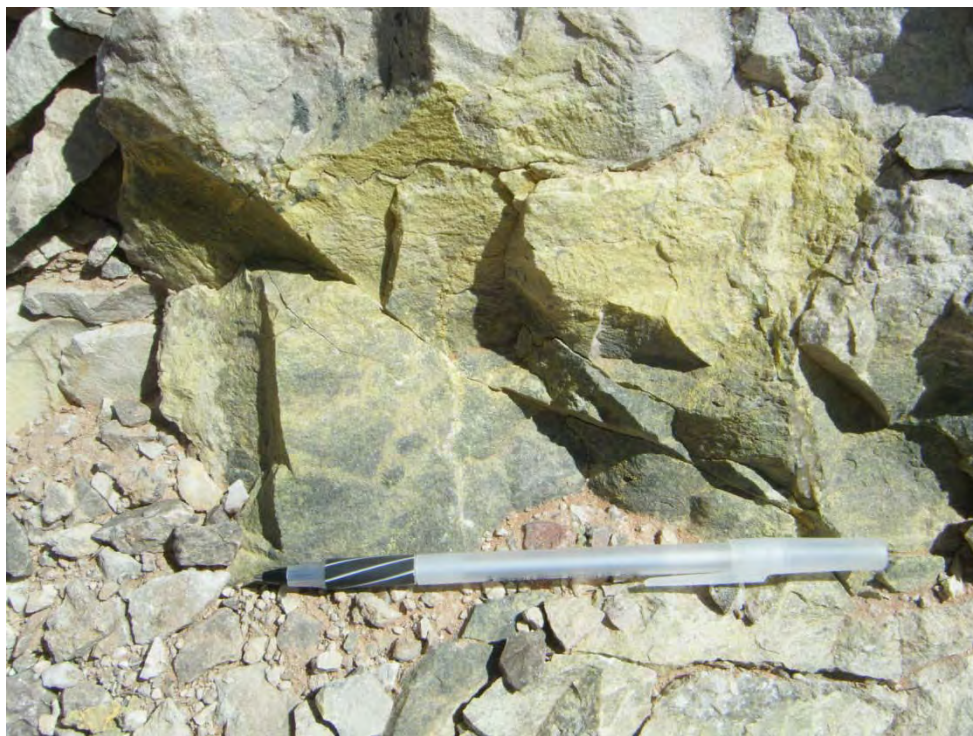
Photo 49-Secondary-type uranium mineralization at radiation survey point Rad-29 (1200  $\mu$ R/hr at 0 ft above ground).

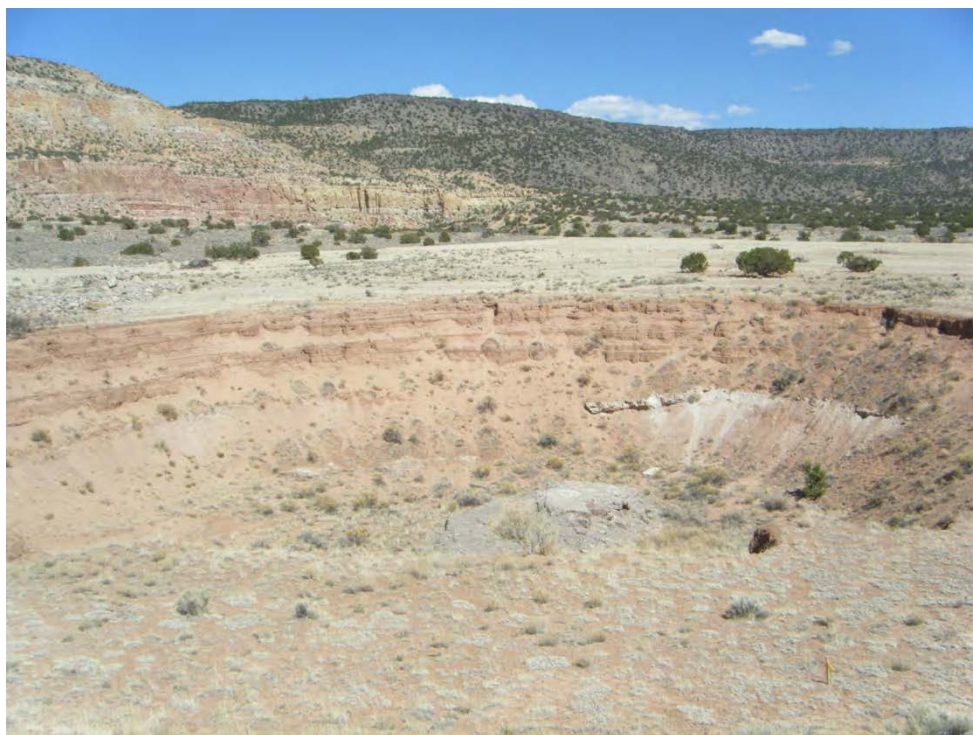
Photo 54-Looking east at Pit-15, the “Eyeball Pit”.

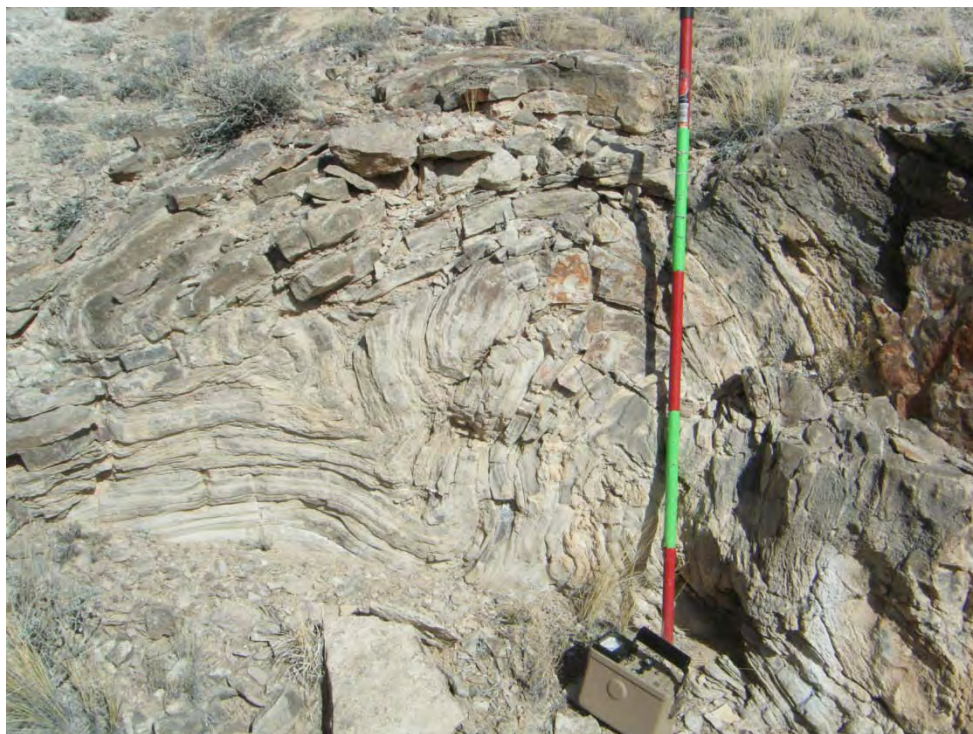
Photo 63-Looking southeast at an intraformational fold in Pit-16.

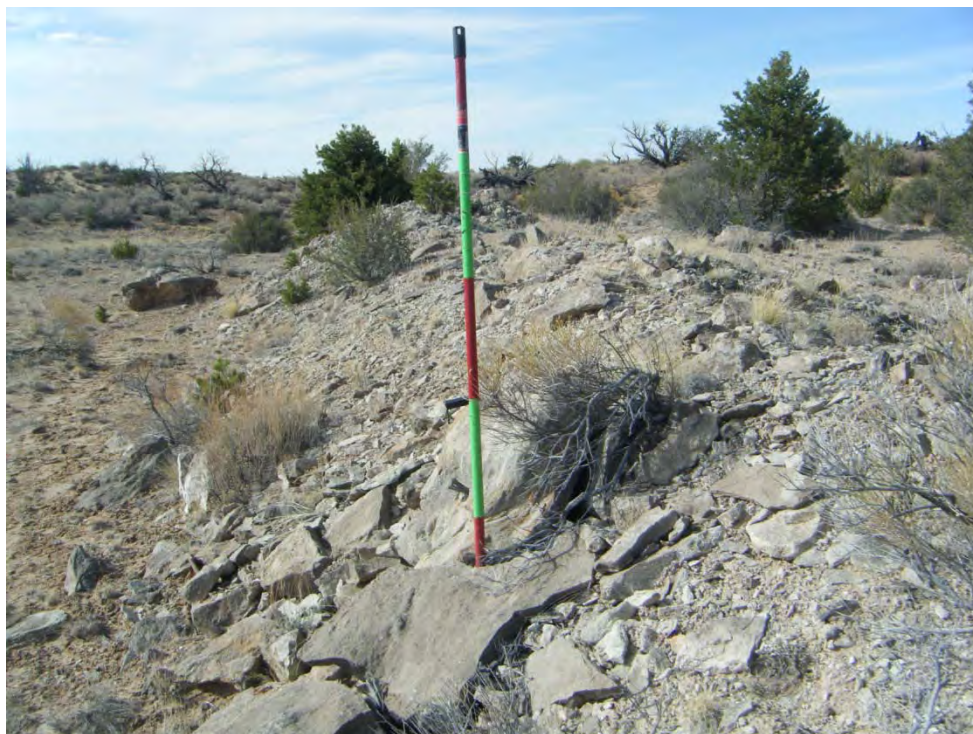
Waste rock piles consist of Todilto Formation limestone, with occasional uranium mineralization resulting in higher gamma radiation readings compared to overburden piles. These features tend to be either low and broad (see Photo 58 in Appendix A) or a series of discrete, conical piles (see Photo 31 in Appendix A). The pile ridges onsite also consist of waste rock (see Photo 67 in

Photo 67-Looking north at PileRidge-2.

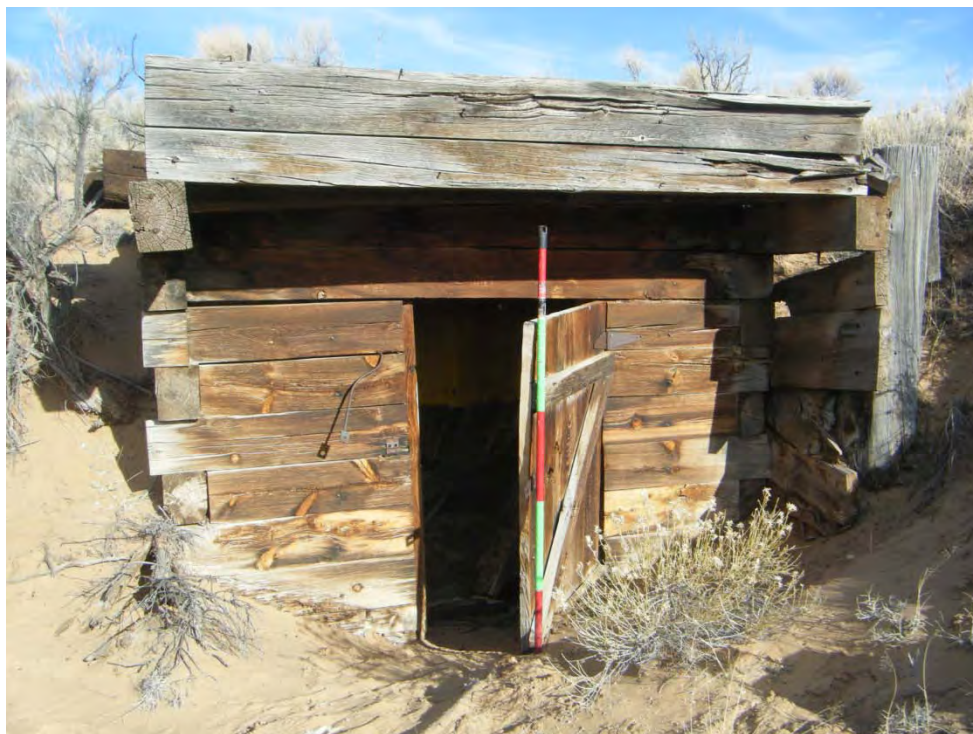
Two mining-related structures were found at the AUM Site, both in the Southern Area. StrucPly-1 is a shed made from railroad ties (see Photo 75 in Appendix A). The interior of the structure contained an old mattress and other debris. StrucPly-2 is mostly buried in sand and contains two doors and a wood roof (see Photo 77 in Appendix A).

Photo 75-Looking east at StrucPly-1.

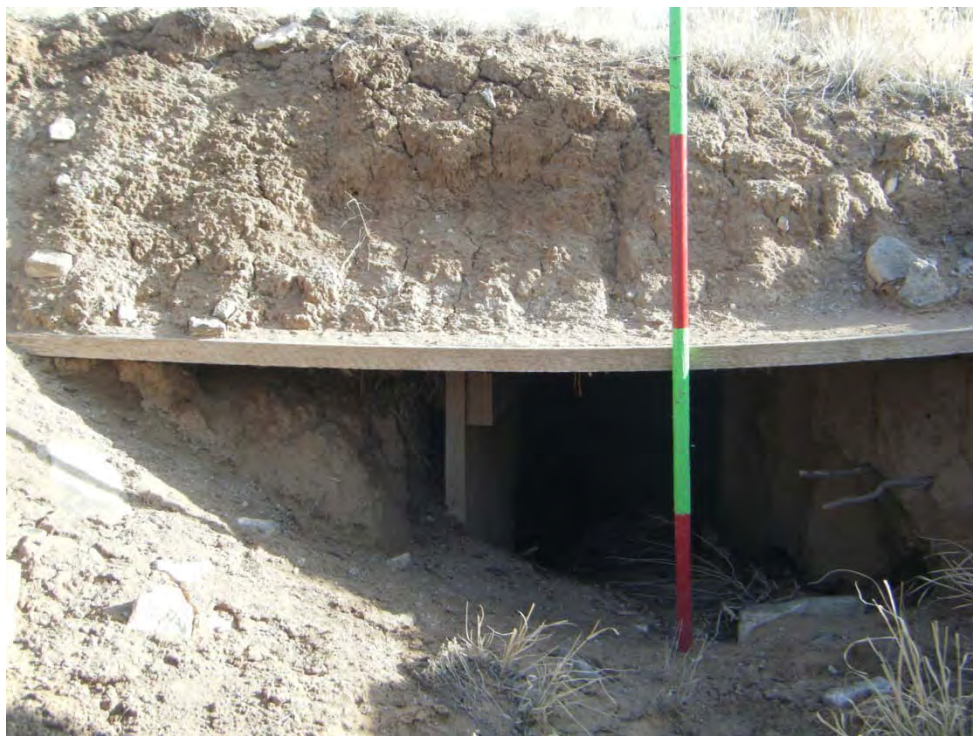
Photo 77-Looking south at StrucPly-2.

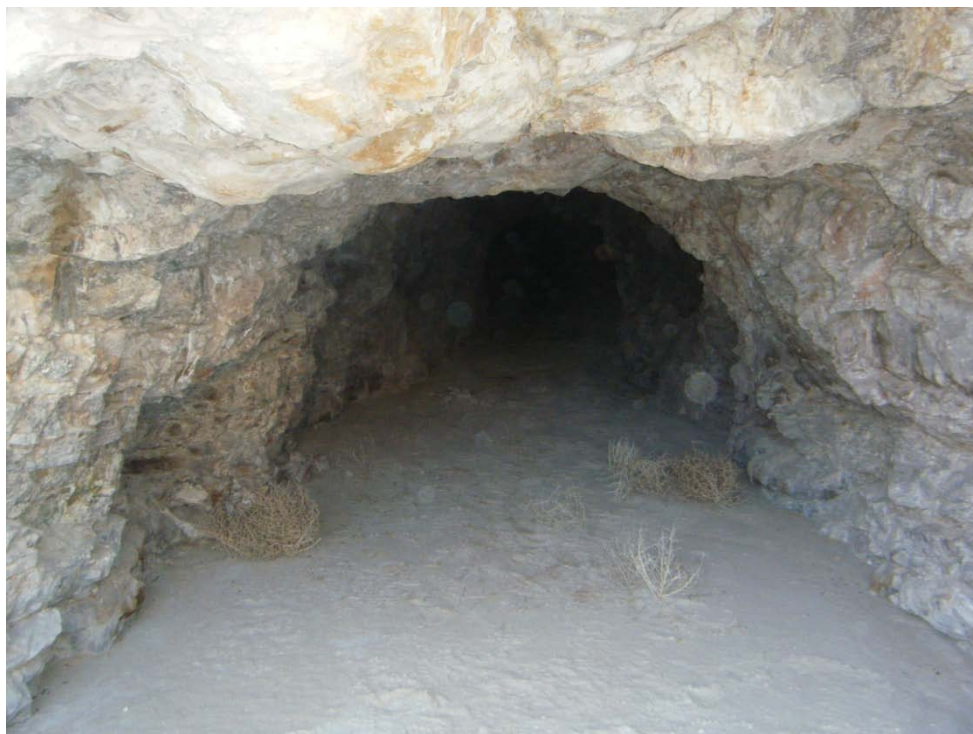
Photo 79-Looking into Adit-3.

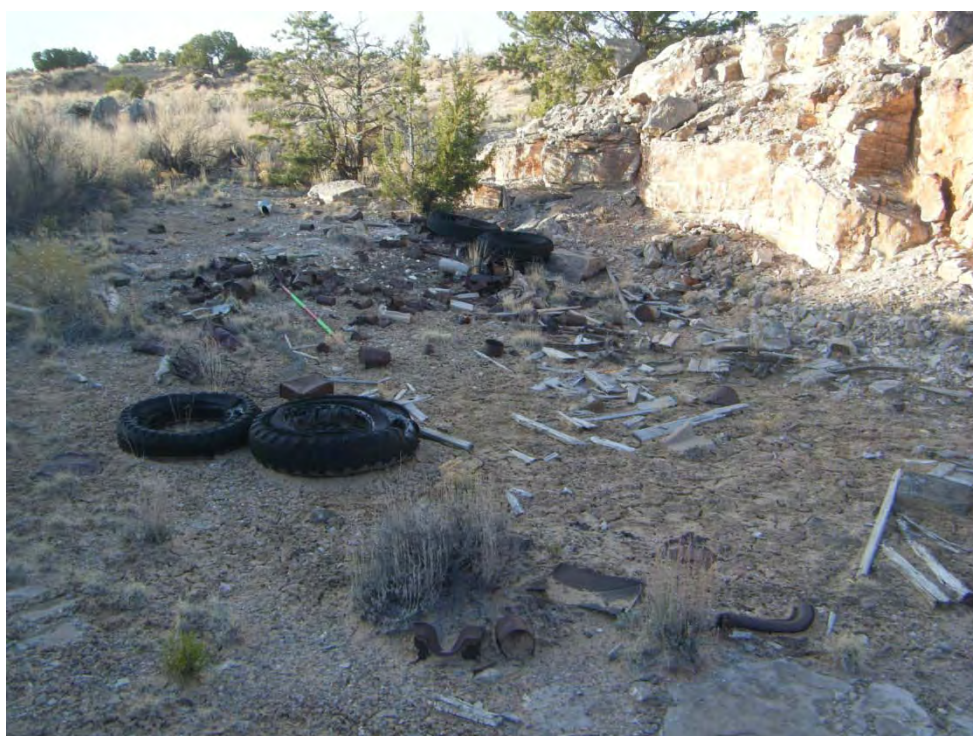
Photo 84-Looking north at a trash dump (DumpPt-2).
